EMERGENCY CONTRACT CERTIFICATION

Nature of Goods or Services: Brick and Masonry repairs, repointing and waterproofing

Re: Duncan Hall 3rd Floor Brick Restoration
North Elevation

Masonry Restoration Limits

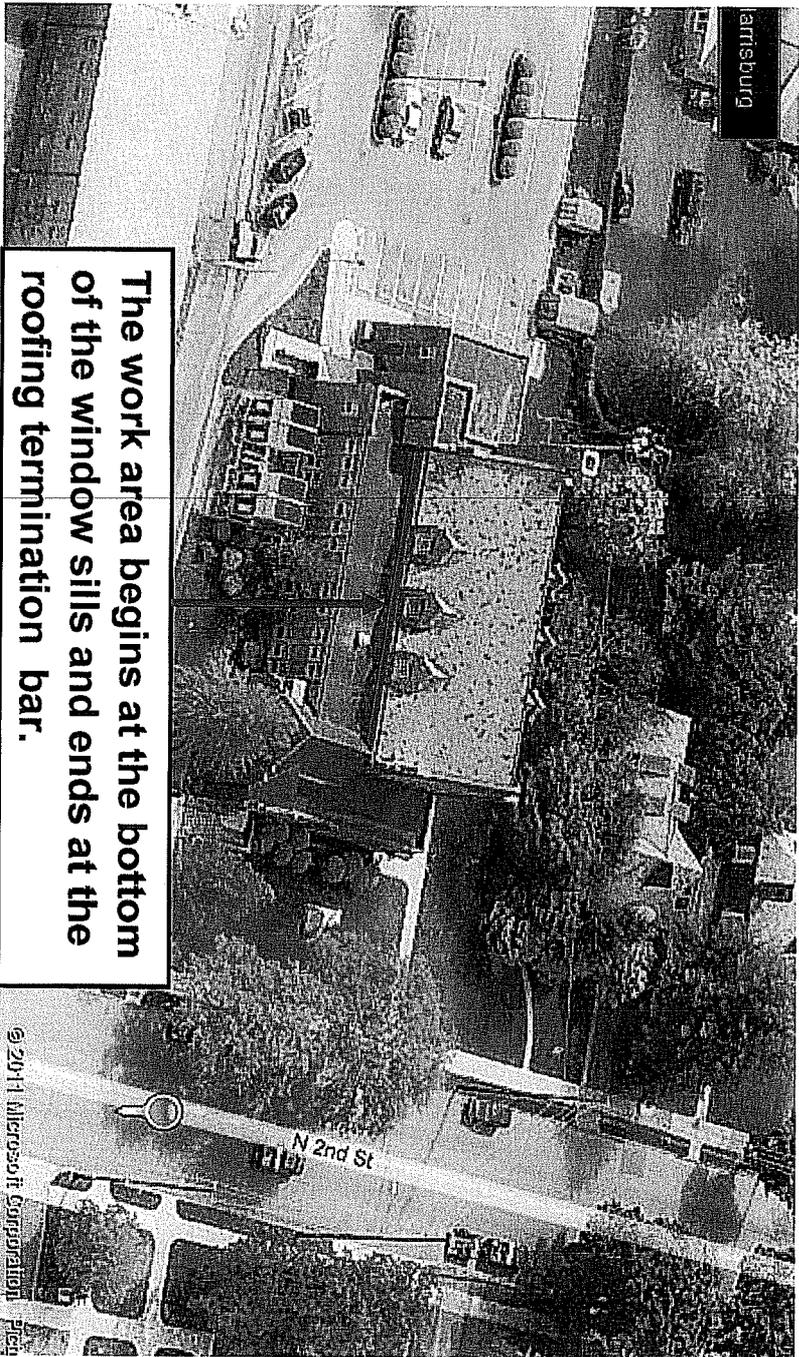
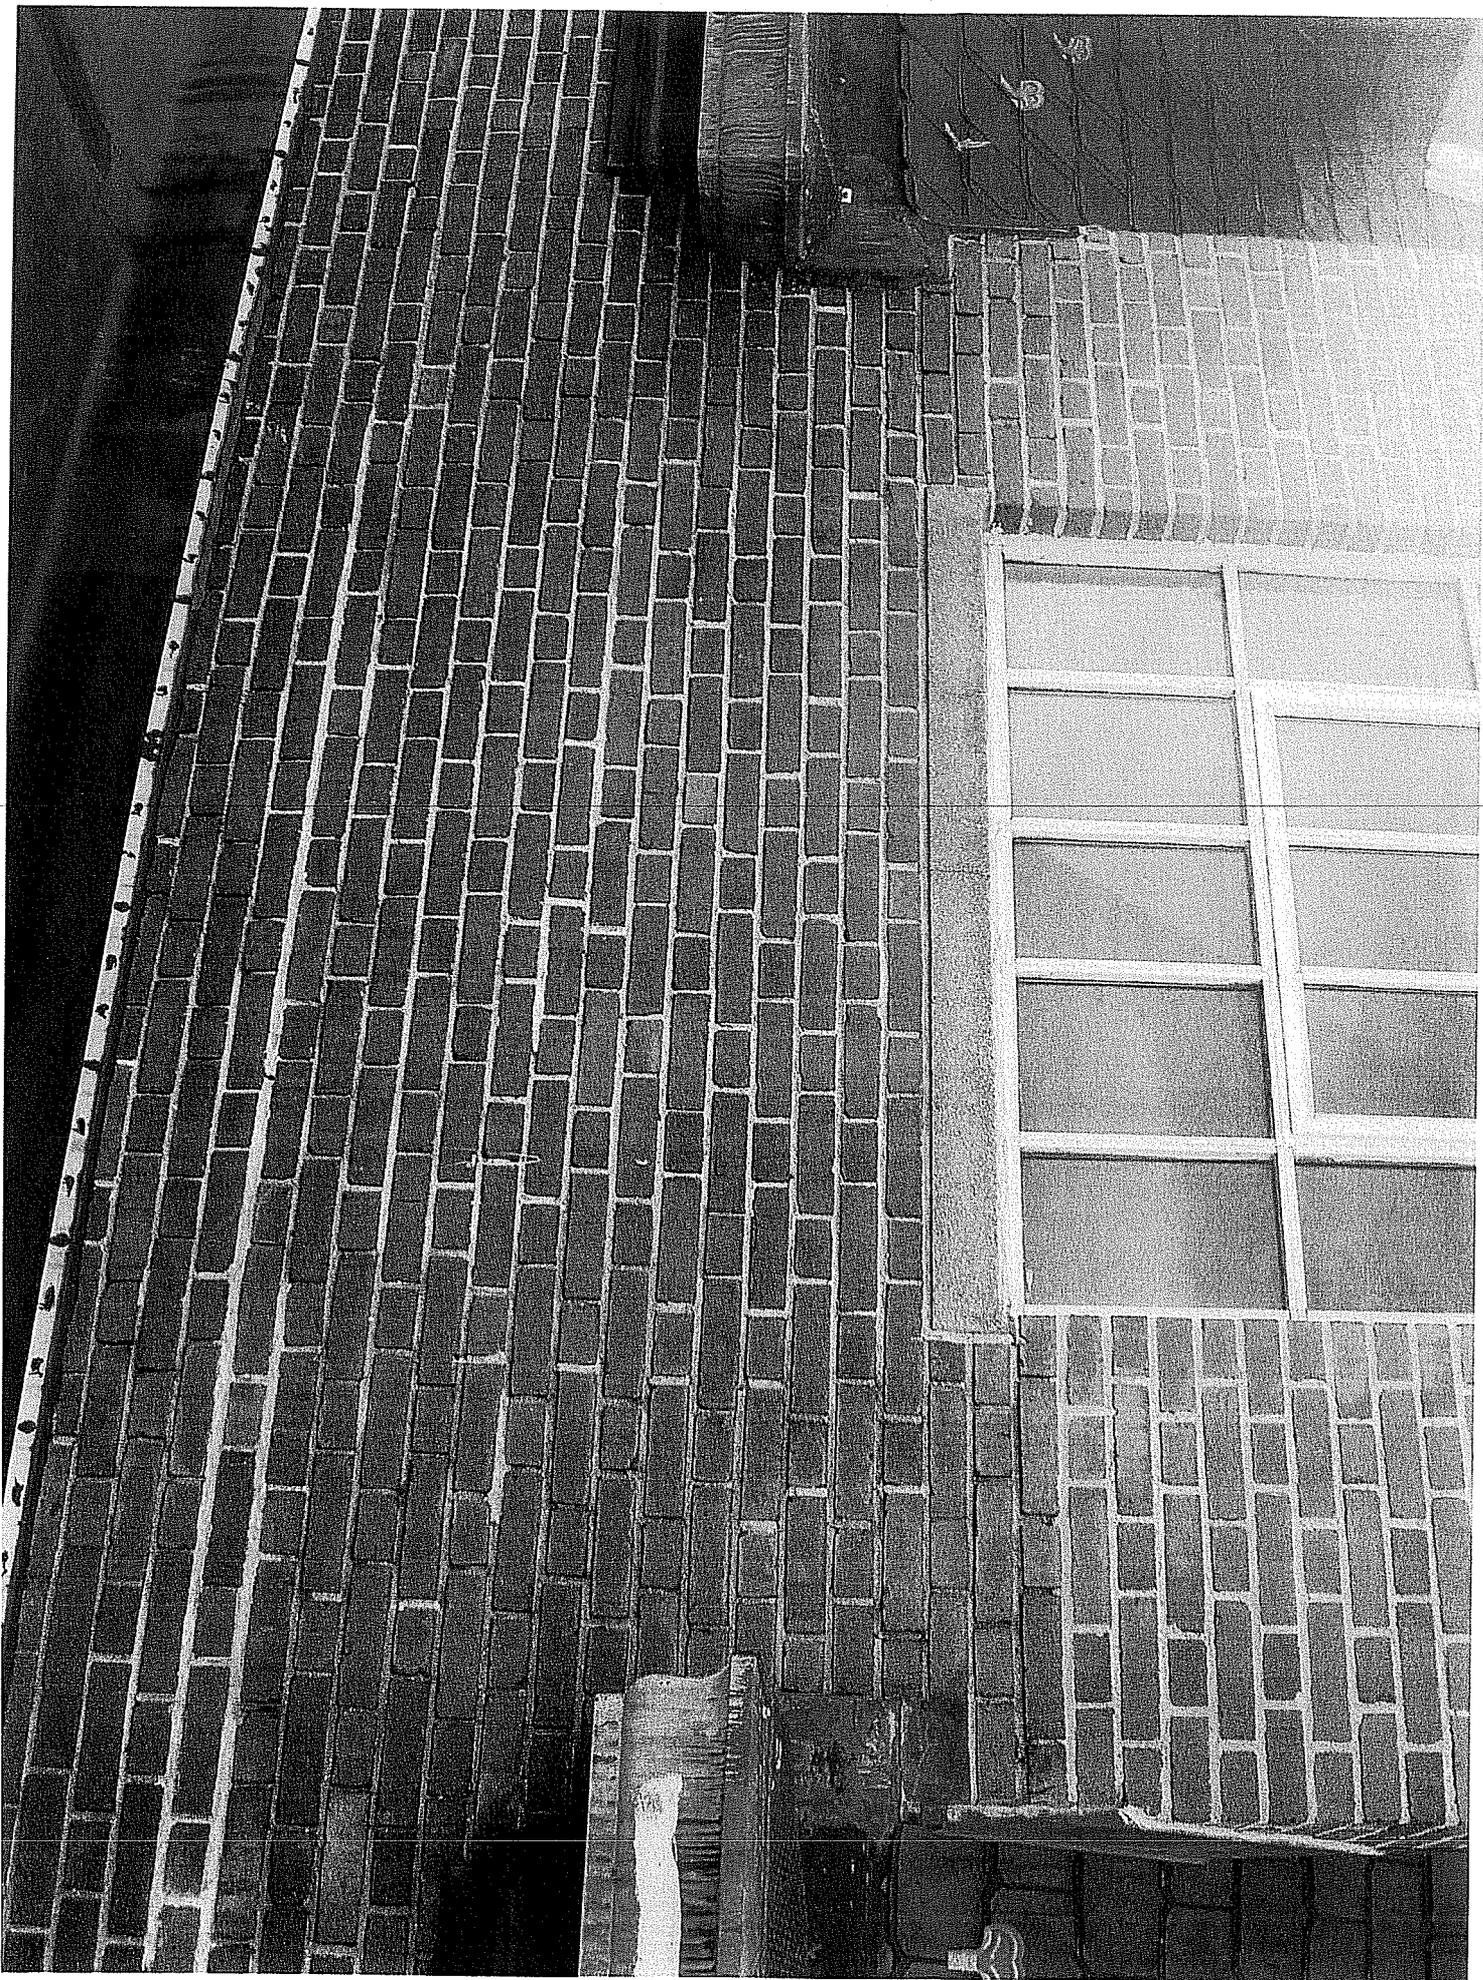
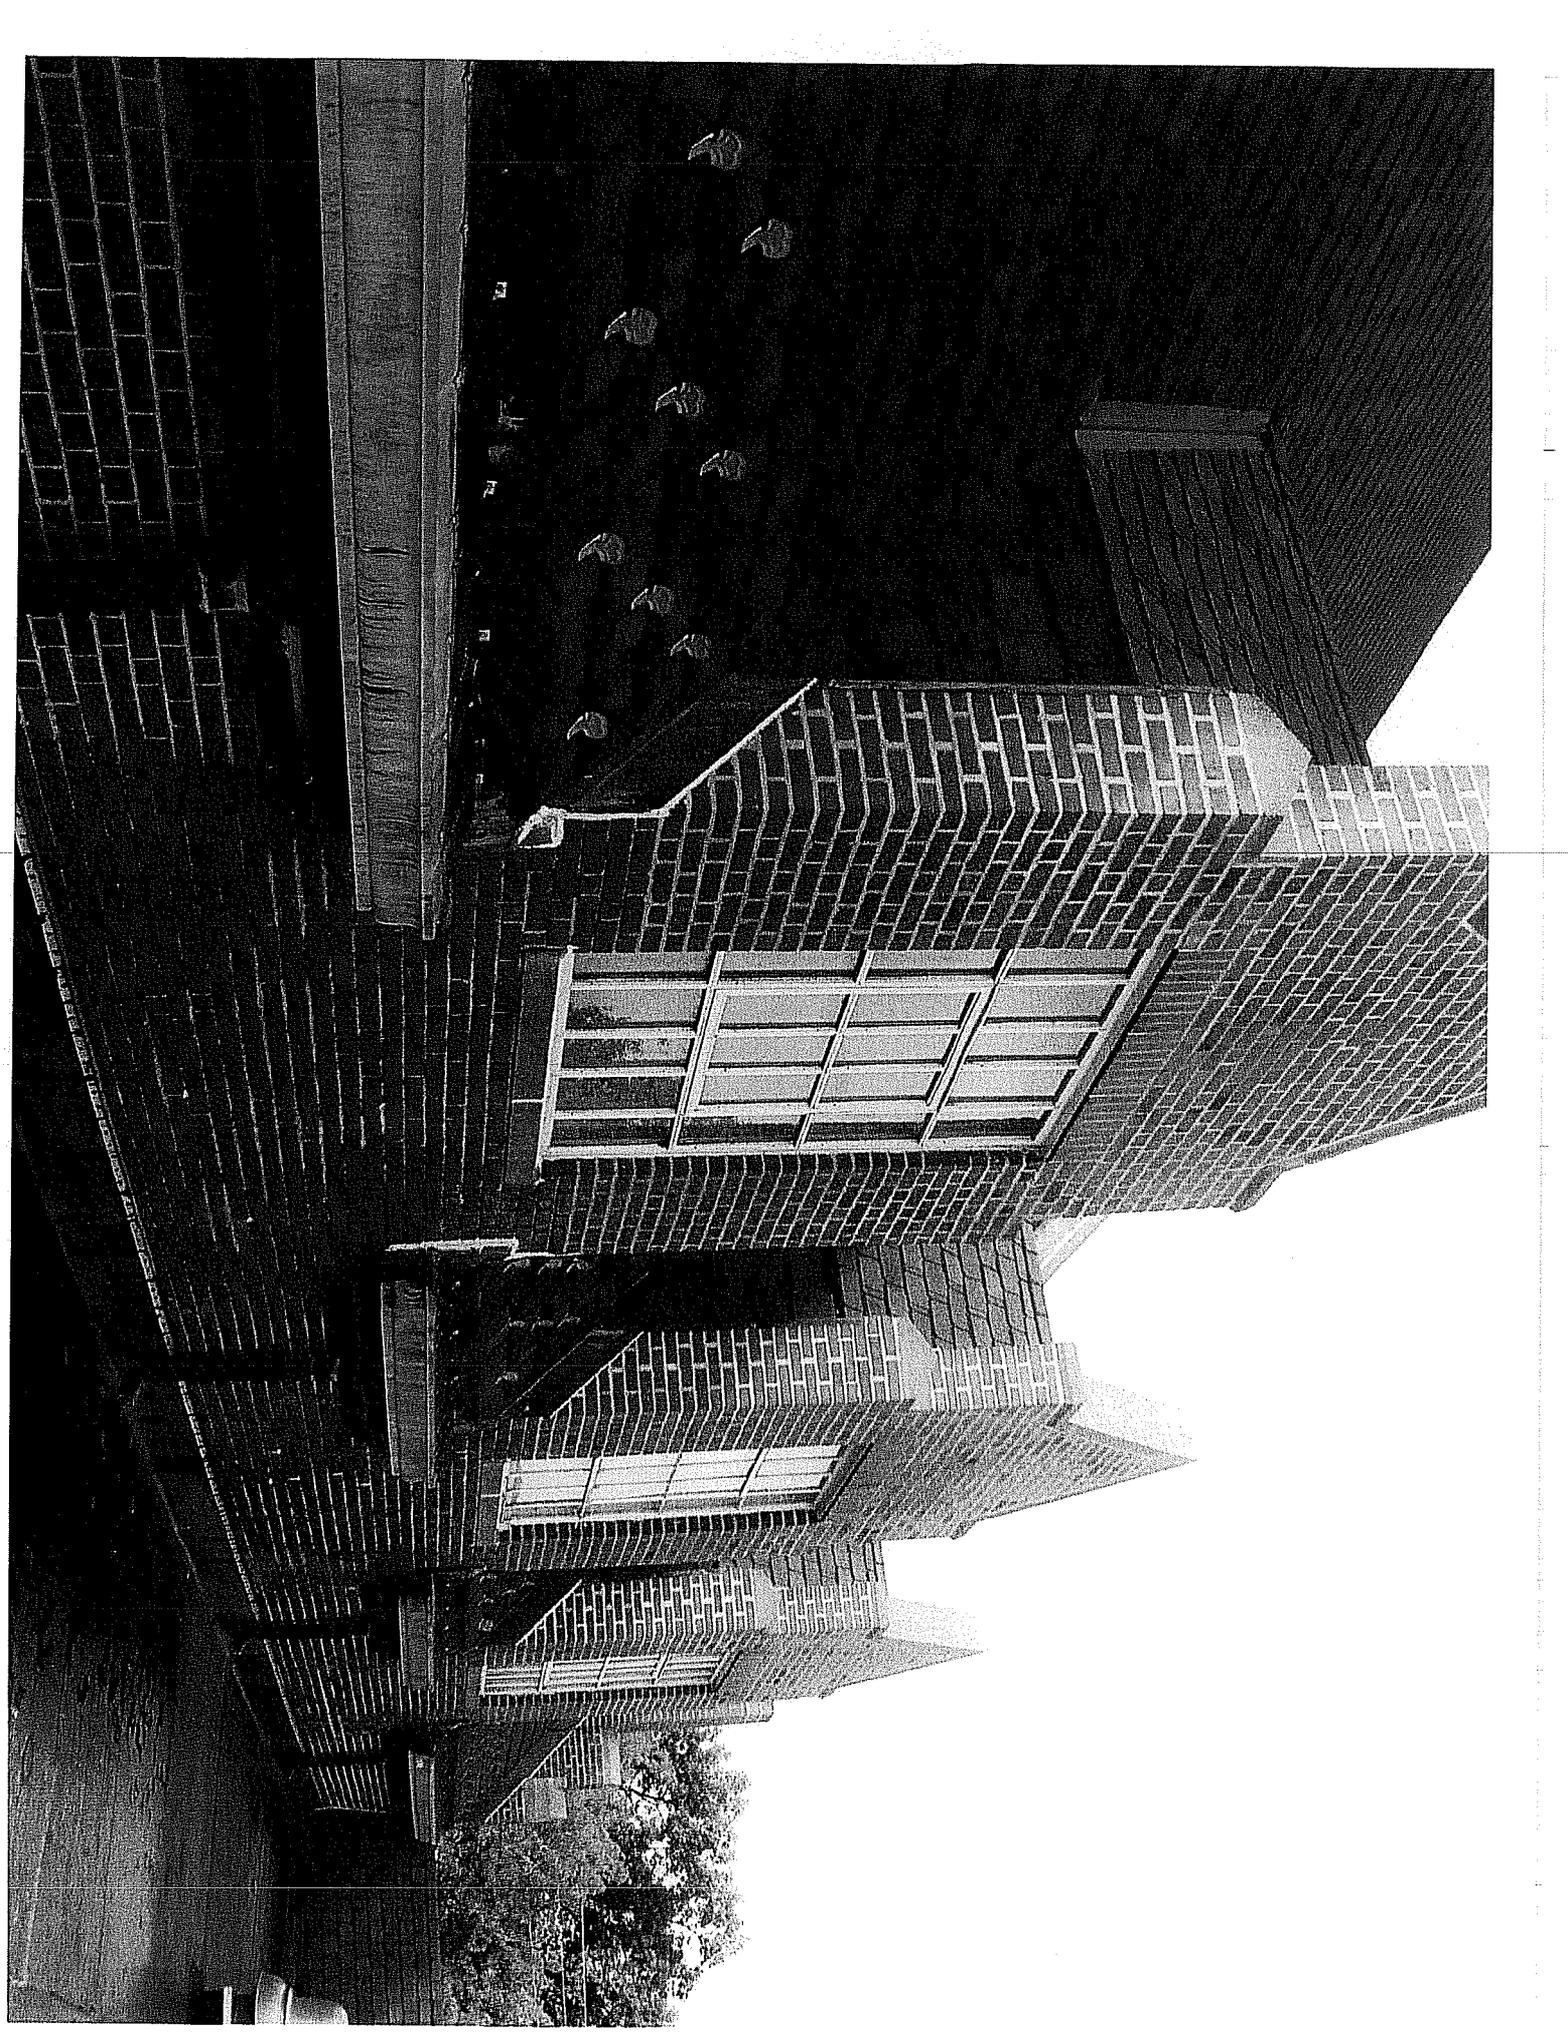
During the course of my visual inspection, I observed deteriorated mortar joints starting at the window sills and extending down to the roofing termination bar. Additionally, a water test was performed by our Roof Maintenance Department and water was observed on the inside wall after several minutes of spraying the lower brick areas addressed in this proposal.

1. See attached overhead photograph and pictures for work limits.
2. Repoint all brick mortar joints within the work area. The work area starts at the bottom of the window sill and extends down to the roofing termination bar.
3. Recaulk the three (3) window perimeters using a silicone sealant.
4. Roof protection.
5. Apply one (1) flood coat of a clear water repellent such as Hydrozo 100. Includes the previously repointed mortar joints located above the window sills.
